DEPARTMENT OF TRANSPORTATION

Quality Assurance and Source Inspection

Contract #: 04-0120F4Cty: SF/ALA Rte: 80 PM: 13.2/13.9File #: 69.28**WELDING INSPECTION REPORT****Resident Engineer:** Siegenthaler, Peter**Address:** 333 Burma Road**City:** Oakland, CA 94607**Report No:** WIR-020479**Date Inspected:** 12-Jan-2011**Project Name:** SAS Superstructure**OSM Arrival Time:** 700**Prime Contractor:** American Bridge/Fluor Enterprises, a JV**OSM Departure Time:** 1500**Contractor:** Zhenhua Port Machinery Company, Ltd (ZPMC), Changxing Island **Location:** Shanghai, China**CWI Name:** Xu Le Feng /Qiu Wen**CWI Present:** Yes No**Inspected CWI report:** Yes No N/A**Rod Oven in Use:** Yes No N/A**Electrode to specification:** Yes No N/A**Weld Procedures Followed:** Yes No N/A**Qualified Welders:** Yes No N/A**Verified Joint Fit-up:** Yes No N/A**Approved Drawings:** Yes No N/A**Approved WPS:** Yes No N/A**Delayed / Cancelled:** Yes No N/A**Bridge No:** 34-0006**Component:** OBG Bike Path**Summary of Items Observed:**

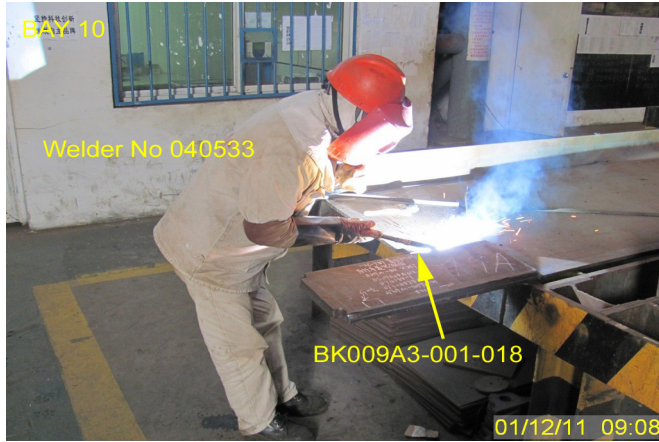
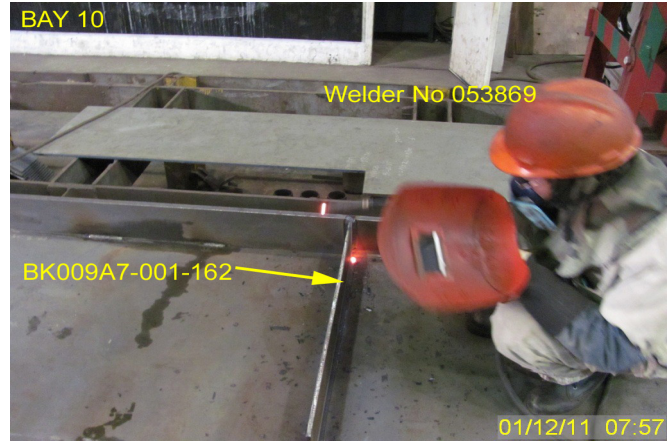
This QA Inspector observed the following work in progress: FCAW welding of weld joint 162 located on BK009A7-001. Welder is identified as 053869. ZPMC Quality Control (QC) is identified as Qui Wen. The welding variables recorded by QC appeared to comply with the Applicable WPS.

This QA Inspector observed the following work in progress: SMAW welding of weld joint 018 located on BK009A3-001. Welder is identified as 040533. ZPMC Quality Control (QC) is identified as Qui Wen. The welding variables recorded by QC appeared to comply with the Applicable WPS.

This QA Inspector observed the following work in progress: SMAW welding of weld joint 002 located on BK004ASD1-032. Welder is identified as 056200. ZPMC Quality Control (QC) is identified as Qui Wen. The welding variables recorded by QC appeared to comply with the Applicable WPS.

This QA Inspector observed the following work in progress: SMAW welding of weld joint 1 located on WSD1-TL6-4-C/D. Welder is identified as 040655. ZPMC Quality Control (QC) is identified as Xu Le Feng.. The welding variables recorded by QC appeared to comply with the Applicable WPS.

This QA Inspector observed the following work in progress: SMAW welding of weld joint 1 located on WSD1-TL6-4-C/D. Welder is identified as 040614. ZPMC Quality Control (QC) is identified as Xu Le Feng.. The welding variables recorded by QC appeared to comply with the Applicable WPS.

This QA Inspector observed the following work in progress: SMAW welding of weld joint 12 located on WSD1-TL6-4-C/D. Welder is identified as 046769. ZPMC Quality Control (QC) is identified as Xu Le Feng.. The welding variables recorded by QC appeared to comply with the Applicable WPS.

This QA Inspector observed the following work in progress: SMAW welding of weld joint 12 located on WSD1-TL6-4-C/D. Welder is identified as 040723. ZPMC Quality Control (QC) is identified as Xu Le Feng.. The welding variables recorded by QC appeared to comply with the Applicable WPS.
